BROKEN CABLE FITTINGS ON WALK-BEHIND TRACTORS (BCS shown)

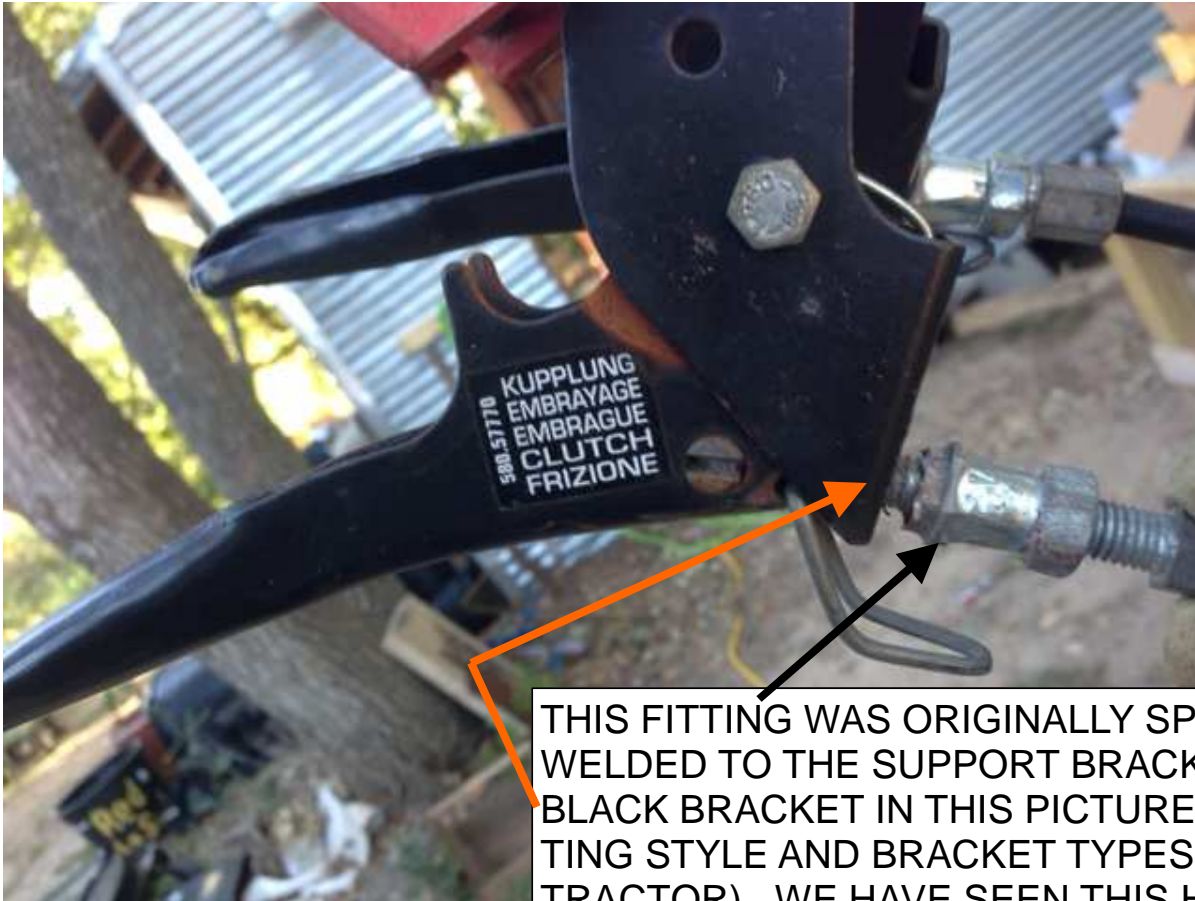
THIS FITTING WAS ORIGINALLY SPOT-WELDED TO THE SUPPORT BRACKET (THE BLACK BRACKET IN THIS PICTURE...THE FITTING STYLE AND BRACKET TYPES VARY BY TRACTOR). WE HAVE SEEN THIS HAPPEN MANY TIMES; TYPICALLY THE CAUSE IS THAT THE BOLT GOT WHACKED AGAINST SOMETHING AND BROKE THE FITTING LOOSE. IT CAN BE RE-WELDED. IN THE MEANTIME, IF YOU NEED TO ADJUST THE CABLE TENSION, JUST HOLD THE BROKEN FITTING WITH A WRENCH OR VISE-GRIPS WHILE PERFORMING THE ADJUSTMENT. (IT DOES NOT ACTUALLY AFFECT THE ACTION OF THE CABLE OR LEVER TO HAVE THIS FITTING BROKEN LOOSE, SINCE WHENEVER YOU PULL THE LEVER, IT PULLS THE FITTING TIGHT AGAINST THE BRACKET... IT JUST MAKES IT DIFFICULT TO ADJUST.)
